# Inzicht in het naoorlogse erfgoed van Paul Felix Uitdagingen in de conservering

Studiedag: Erfgoed in goede handen - Naoorlogs erfgoed: bedreigd én geliefd

Spreker: Warre Onnockx

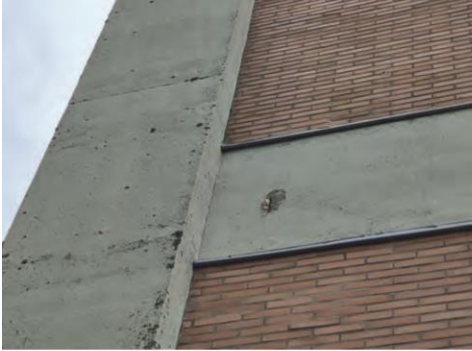
The tower's exterior has seen some maintenance, with the concrete structure receiving a protective finishing layer of paint. While the overall exterior concrete structure is fairly sound, there are specific areas, particularly at the level of the water tank, underneath the superstructure, where deterioration has occurred. The tower's substructure, which consists of six levels of a visible concrete skeletal framework, remains largely intact, though some areas exhibit signs of concrete deterioration.

**Fig 4:** Spalling of concrete at the back façade, caused by the the larger volume of the corroding steel.

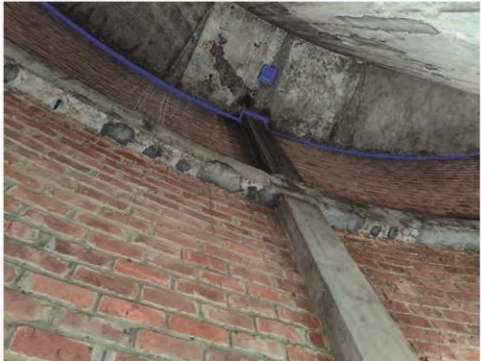
Inside the superstructure, with its cylindrical design cantilevered over concrete beams, one can see visible signs of wear. Parts of the exterior of the concrete tank have undergone multiple repairs, but issues such as concrete scaling and exposed reinforcement continue to require attention. Repairwork has been done but despite these efforts, signs of concrete rot, cracks, and scaling persist, especially in areas where the original material has been patched with repair mortar. The presence of moss and biological growth in the basin space indicates the humid conditions within the structure, which can accelerate the decay of the concrete. Plans are on the table to replace the (non-original) windows in the top section of the tower. Regular water quality checks are conducted every month, but also monitoring and maintenance for the building should be checked on a regular basis.

**Fig 6:** The repairwork on the tank and mantle inside the superstructure.

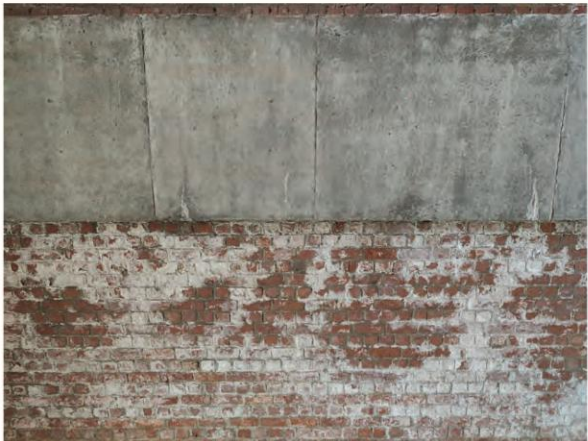
The on-site formworked and poured central staircase is in good condition. Certain parts of the infill brickwork have been affected by salt efflorescence, a sign of moisture infiltration. Openings have been made in the brickwork at the top section of the tower to accommodate antennas and pipes, reflecting the ongoing use and adaptation of the structure.

**Fig 8:** Effluorescence showing the present of salts due to moisture transport. Its presence is most prominent in horizontal strokes near the concrete, indicating a transport of salts from the concrete to the brickwork where it subsequently dries out.

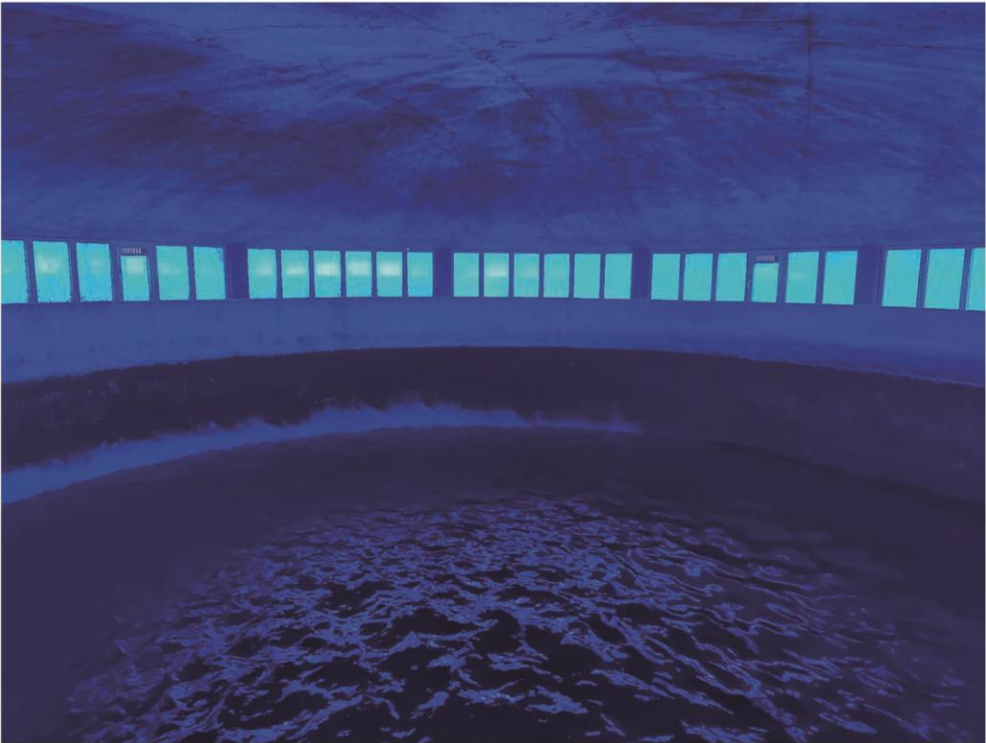
**Fig 9:** The humid environment of the watertank posing risks for rapid concrete deterioration. The blue tinted windows are meant to filter sunlight, preventing excessive bacteria growth. The space is covered with algae.

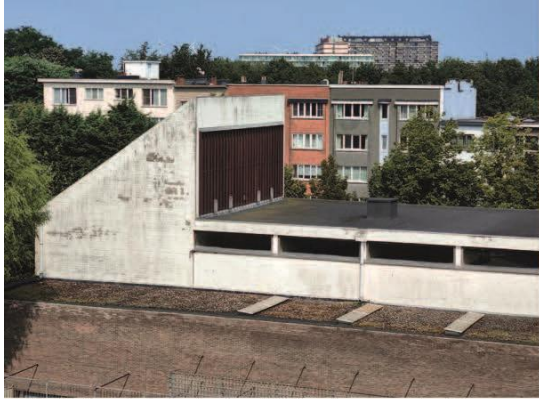
The bricks at the chapel's basement are moist, a problem likely caused by the absence of a proper roof overhang to protect them from rainwater. In several locations, the bricks have undergone significant degradation, displaying efflorescence, indicating an already prolonged exposure to moisture. The chapel's original woodwork, though mostly intact, is in poor condition due to bad maintenance. The windows on the south side have deteriorated significantly, likely due to UV-exposure. In 2018, repairs were made to the roof, but leakages continue to persist. Asbestos-containing drainage pipes have been replaced.

**Fig 55:** Chapel exterior showing exfoliation of vapour proof paintlayer. Moist bricks due to absence of a sufficient roof overhang.

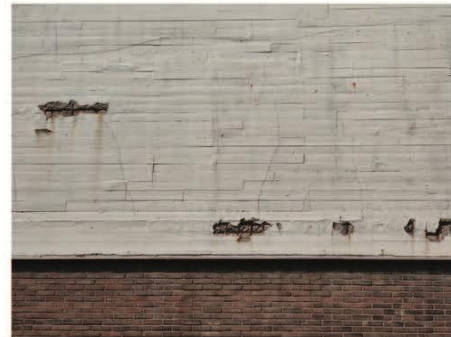
The chapel is currently in a poor state of conservation, presenting a neglected appearance that raises concerns about its future existence. The building's exterior and interior both exhibit significant signs of deterioration, which require immediate attention to prevent further damage. The exterior of the chapel shows clear evidence of extensive deterioration, particularly in the form of concrete decay. In several areas, concrete spalling is visible, with exposed reinforcement mesh, flaking, and rust spots. This damage is primarily due to inadequate concrete coverage, which has failed to protect the reinforcement.<sup>171</sup> Additionally, both fine hairline cracks and larger fissures can be seen across the concrete surfaces.

**Fig 56:** Flaking, scaling and cracking due to concrete carbonation. The corrosion of reinforcement leaving stains.

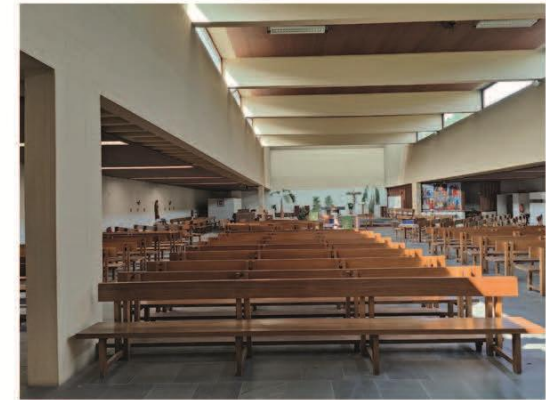
The interior of the chapel also suffers from neglect. The once-exposed concrete and brick walls have been painted with a yellowish colour, which undermines the original design intent of exposed materials. Water leaks in the past have caused damage to the wooden ceiling panels. In the rear corners, diagonal cracks in the masonry can be observed, indicating potential stability issues. One of the roof domes is completely overgrown, while others show signs of condensation problems, suggesting issues with ventilation and moisture control. Despite these problems, some original features have been well-conserved, such as the stone flooring and simple wooden benches. The confessionals, designed as rectangular boxes in white formica with narrow strip windows, are also still intact.

**Fig 64:** Chapel interior showing the painted beams and walls. Original wooden benches.

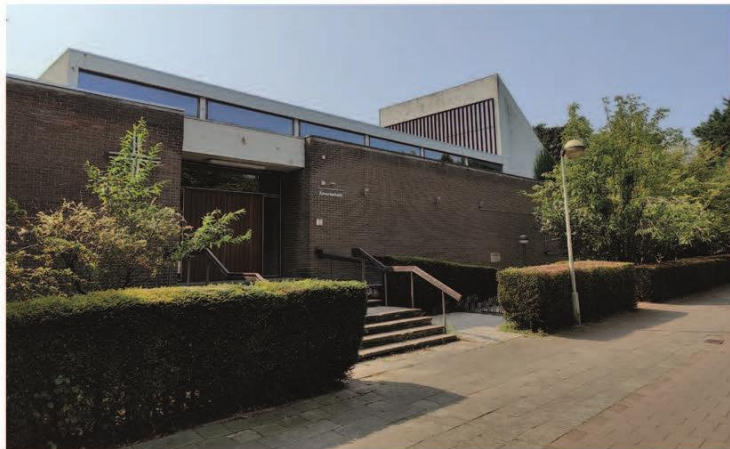
**Fig 57:** Northern entrance facade showing moist bricks at the top and concrete deterioration. Biological growth on the light cap.

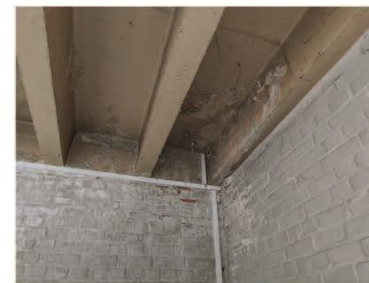
**Fig 65:** Degradation due to moisture.

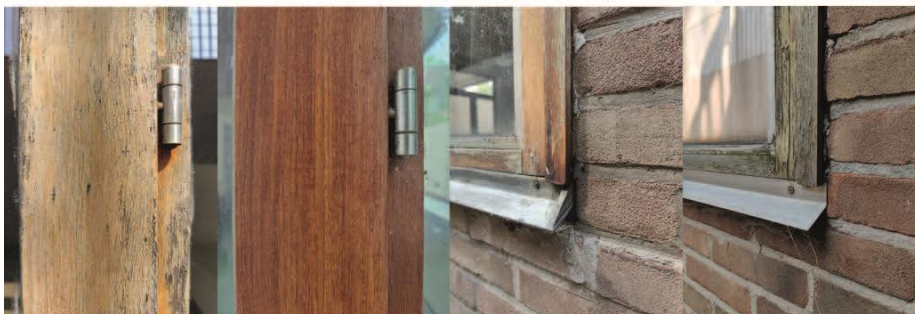
**Fig 58:** Frame exposed to UV. **Fig 59:** Frame sheltered from UV. **Fig 60:** Original dripping element. **Fig 61:** Replaced dripping element

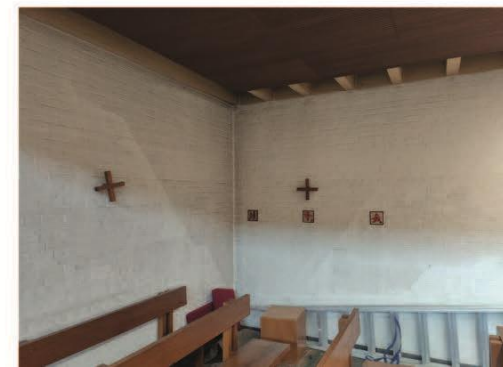
**Fig 67:** Diagonal cracking in corner, indicating stability issues, vertical settlements.

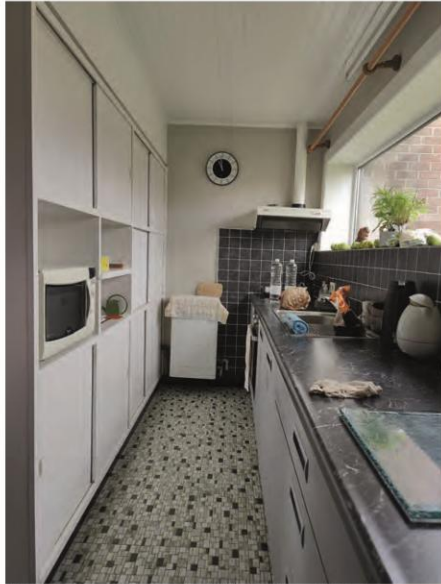
**Fig 112:** In many houses the original cabinet divider between kitchen and living room (visible on the left) has disappeared.

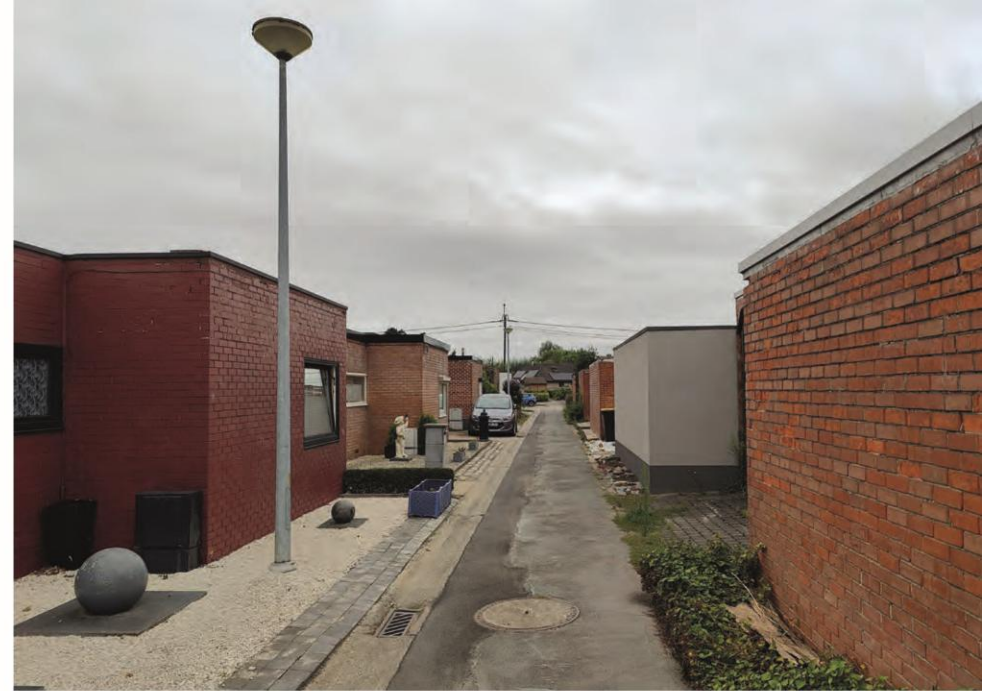
One of the main issues however, is the inconsistency in the materials used for renovations. As residents sought to improve their homes, various finishing materials were chosen, ranging from slate and plaster to wooden shingles and different types of paint in assorted colours. Moreover, many patios, once integral to the design, have sometimes been entirely built over. This has led to the risk of losing the uniformity and integrity of the neighbourhood. Additionally, some houses have been retrofitted with insulation and the replacement of asbestos air ducts. Some homes are also effected by rising damp, further complicating conservation efforts.

**Fig 114:** Low-traffic street showing the multiple different new facade finishings and roofs. Some of the bricks of the original façades are showing deterioration.

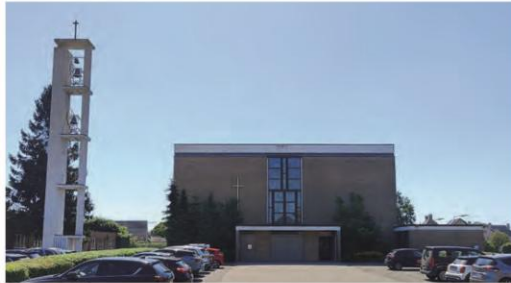
Externally, the roofs of the entrance and communal spaces have been insulated and fitted with new roofing, resulting in a noticeable increase in the roof profile. The original concrete gargoyles have been replaced with steel ones and numerous additional air ducts, chimneys, lampposts, and rainwater drainage systems have been installed, altering the façades original aesthetic. A south-eastern annex building has also been added. The bell tower has not undergone many modifications, apart from new climbing hardware.

**Fig 83:** Bell tower and church entrance.  
Difference in roof height at the eave of the lower volumes due to insulation.

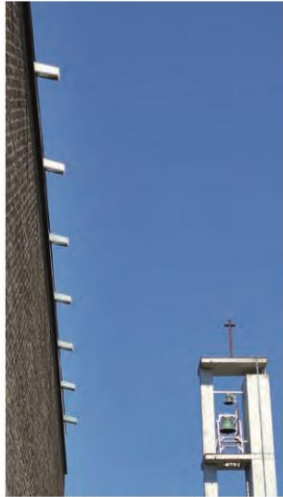
**Fig 85:** Bell tower and replacement of the concrete gargoyles with steel ones.

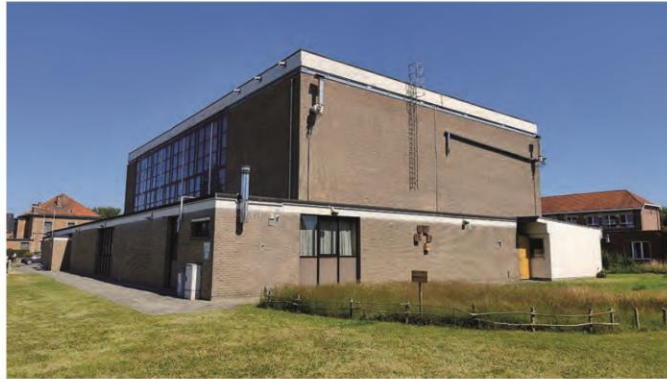
**Fig 84:** Numerous additions like heating outlets, air ducts, chimneys, rainwater drainage.  
Annex building in white.

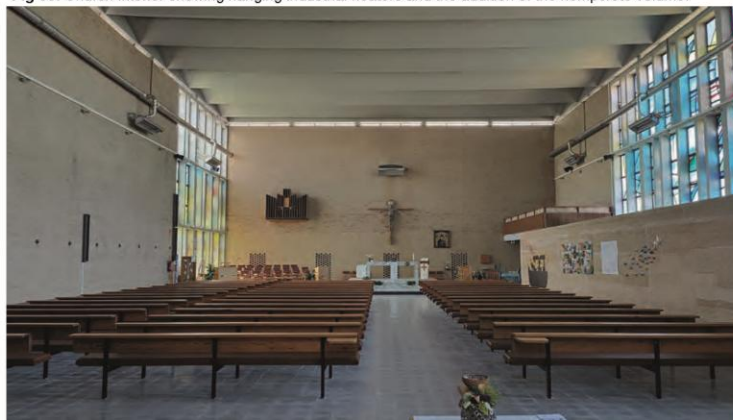
The interior has been further altered by the installation of industrial heating appliances and air ducts, which have been mounted around the walls, disrupting the church's original design. The once bare concrete pleated roof structure has been painted. At the ceiling, there is also a concerning black deposit, primarily in the folds of the roof, possibly indicating mould formation due to condensation issues. Moisture damage is also evident in the corner of the balcony, possibly caused by a leak or condensation due to thermal bridging. Lastly, some of the wooden frames at the entrance are showing cracks and are in need of repair.

**Fig 86:** Church interior showing hanging industrial heaters and the addition of the hempcrete volume.

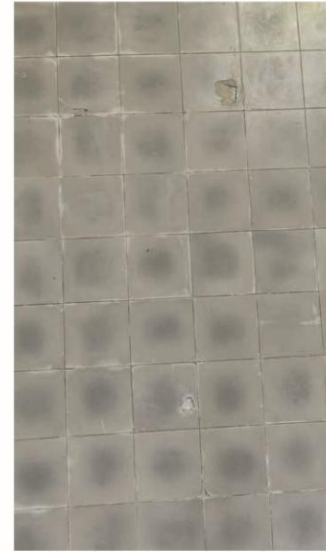
Inside the church, the cement tile flooring has suffered noticeable degradation and chipping, especially in high-traffic areas. The side aisle gallery on the right has been closed off from the main church, and the original glass-in-concrete windows by Michel Martens have been replaced by stained glass by Daniël Theys, with PVC windows added on the exterior for protection. The benches are no longer the original furniture. Recently, an extra volume made of hempcrete has been placed inside the church on the right, intended for children's activities.

**Fig 87:** Chipping of the cement tile flooring.

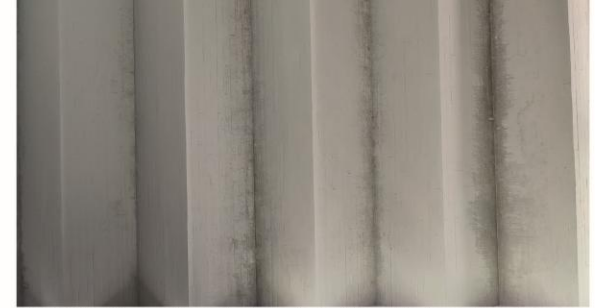
**Fig 88:** Possible mould formation in the pleats of the painted concrete roof structure

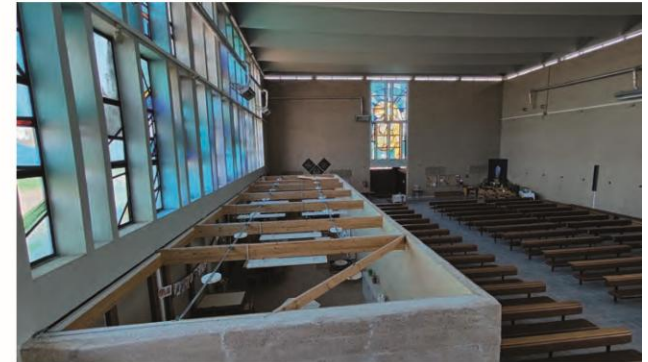
**Fig 89:** Additional volume set-up in hempcrete.

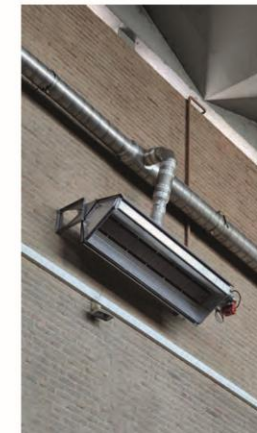
**Fig 91:** The flashy heaters used to warm up the church.
